22
1st Part of Report
No. AAEE/866/5

SHACKLETON MK. 2 PHASE 3

NAVIGATION AND RADIO C.A. RELEASE TRIALS

**SQN. LDR. D. A. STONEHOUSE, R.C.A.F. AND FLT. LT. R. E. GRIFFITHS, B.Sc.(Eng.)
NAVIGATION AND RADIO DIVISION**

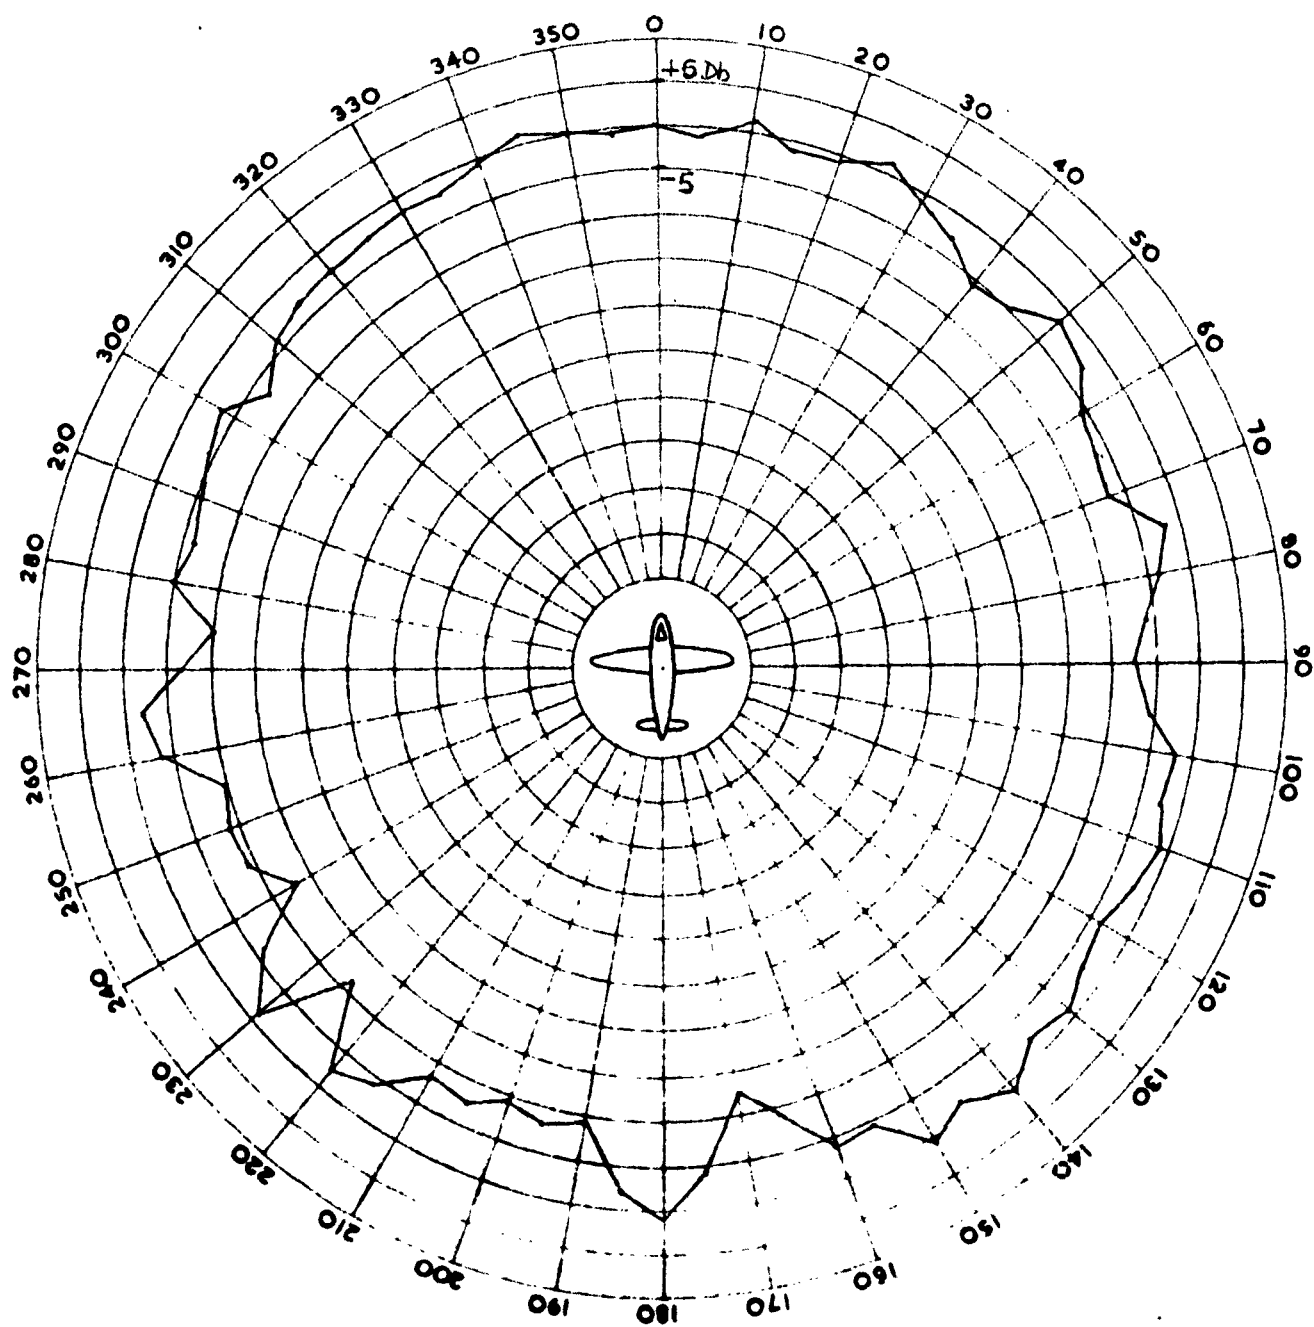
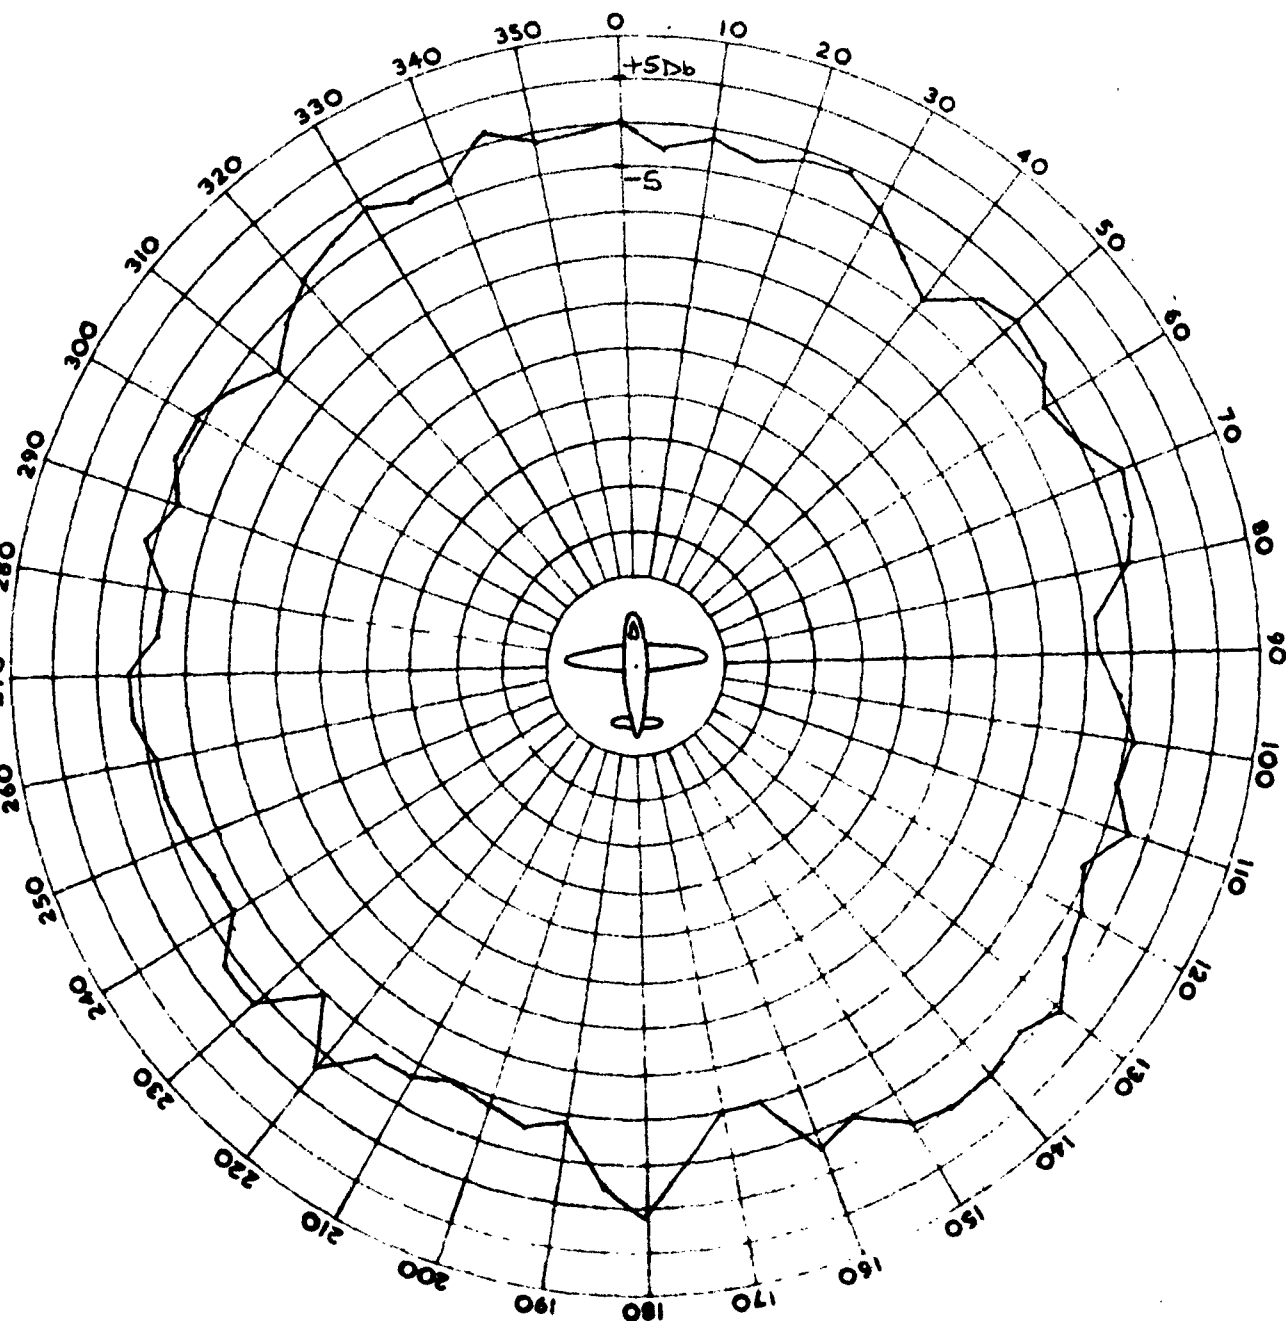
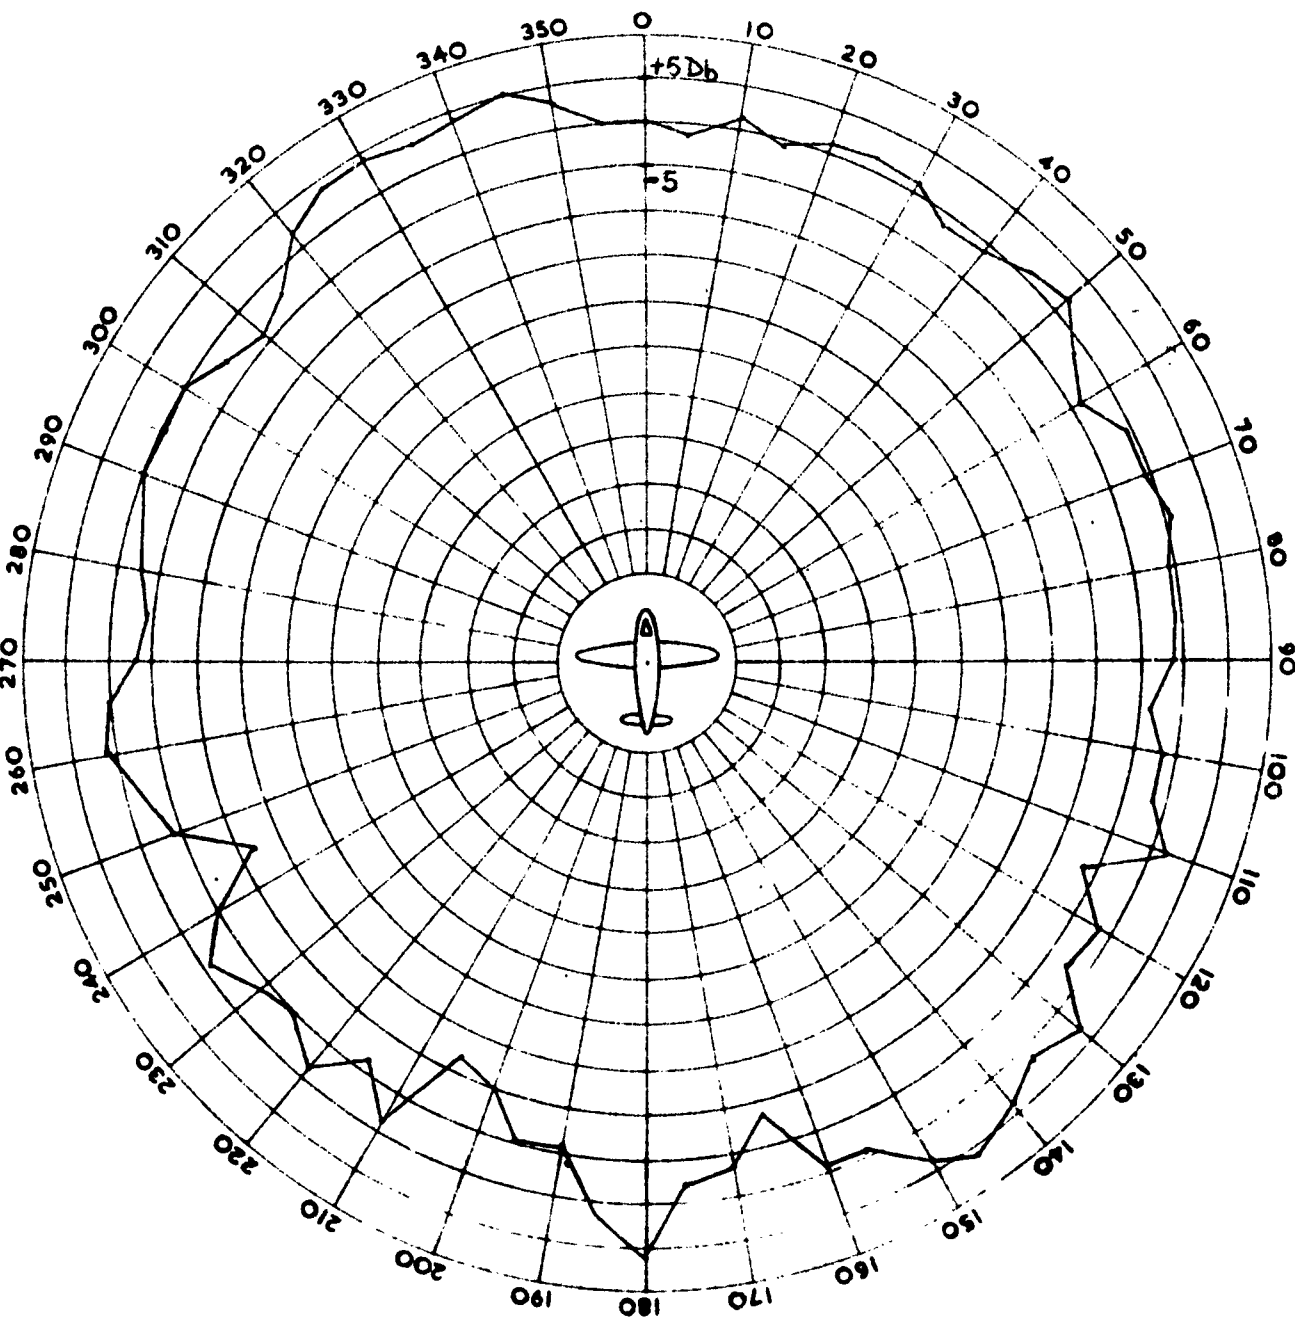
The installation of the Twin Sonobuoy 1C system is adequate including the new forward aerial. The radiation patterns of this aerial (Figures 7 - 10) indicate that its performance matches that of the existing aerial. It does not conform to Specification RAE/XRSP 3381 in that there are excursions in the pattern greater than 2 dB from the head on aspect, but acceptance of this is recommended in view of the practical results obtained. The Sonobuoy Homer and Homer/Violet Picture Switching Installations are analogous to the Phase 2 fit; the aerial installations continue to be unsatisfactory as exemplified by the failure of both aerials under moderate icing conditions in flight.

C.A. release is recommended for the sonics system except for the homer aerals, but it is recommended that further investigations be made into the susceptibility of the sonics receivers to H.F. harmonic interference (see Appendix II). The homer aerial fault is well known and must be rectified without delay.

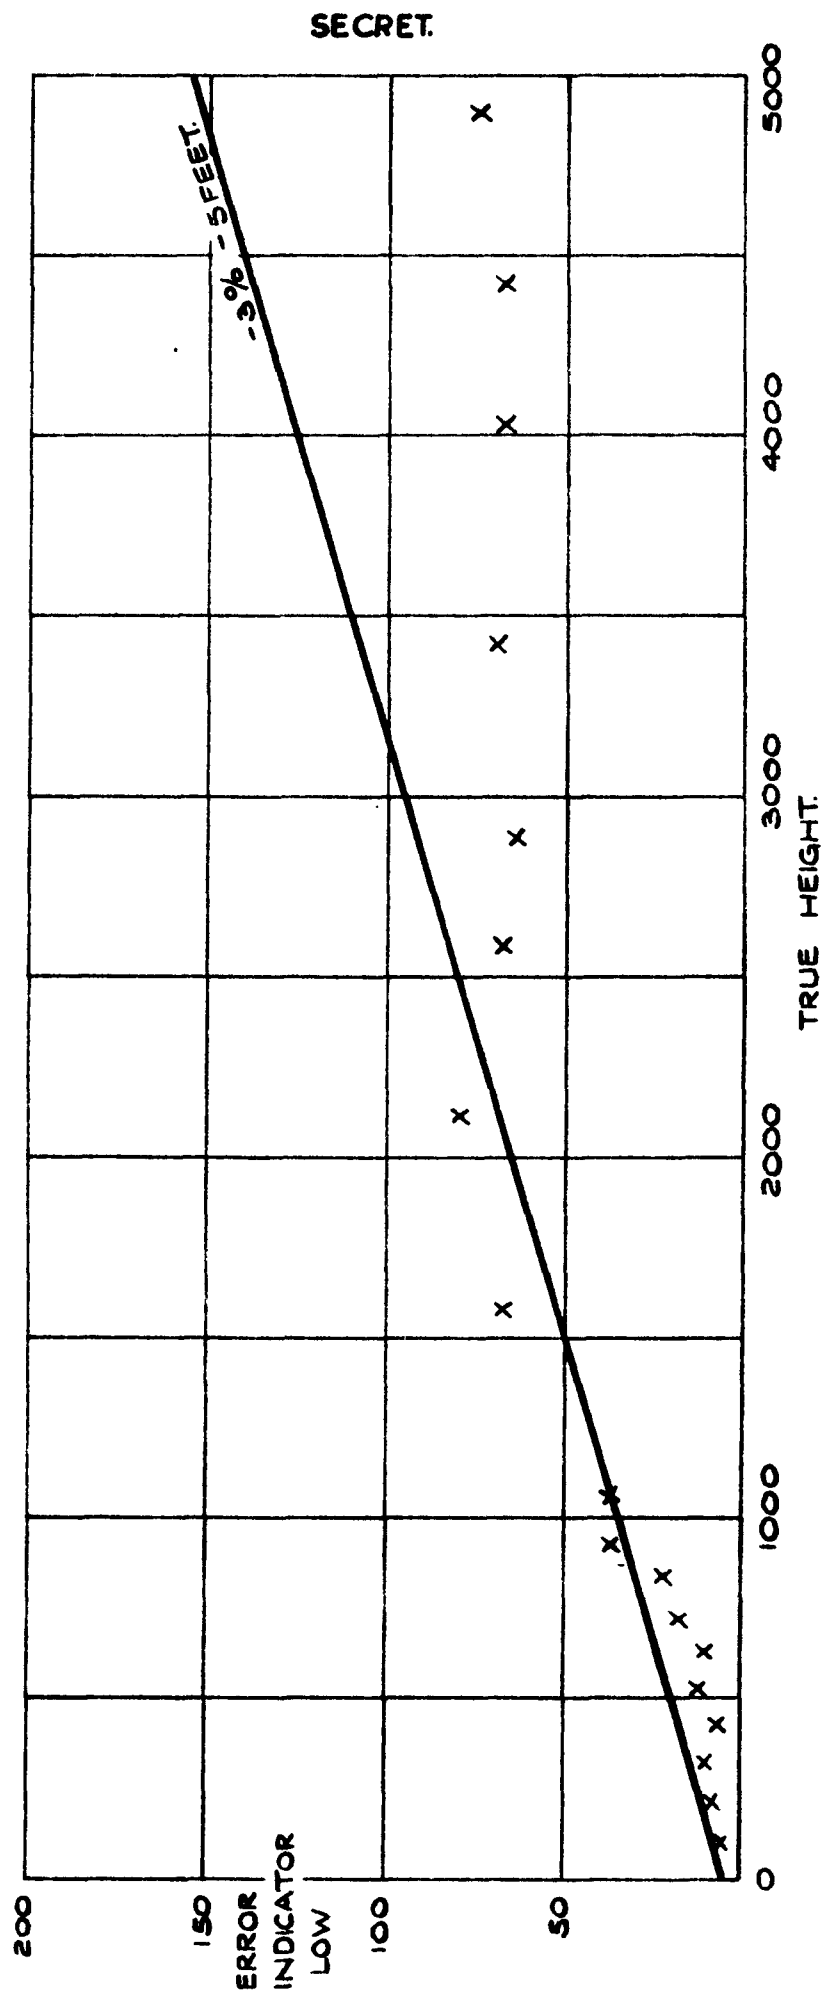
FIG. 11.

The accuracy of the equipment was ascertained by calibration runs against the kinetheodolites at R.A.E. Aberporth and by sea-to-land runs near Burnham-on-Sea. The results of the Aberporth trials in the height bracket 100-5,000 feet are shown in Figure 11 and the sea-to-land results are in Figure 12. From the results the overall accuracy over land and sea is within the limits $\pm 3\%$ of height ± 5 feet.

C.A. release is recommended for the Mk. 5A radio altimeter within the accuracy limitations of $\pm 3\%$ of height ± 5 feet and on the condition that reliance is not placed on the equipment readings below 50 feet.

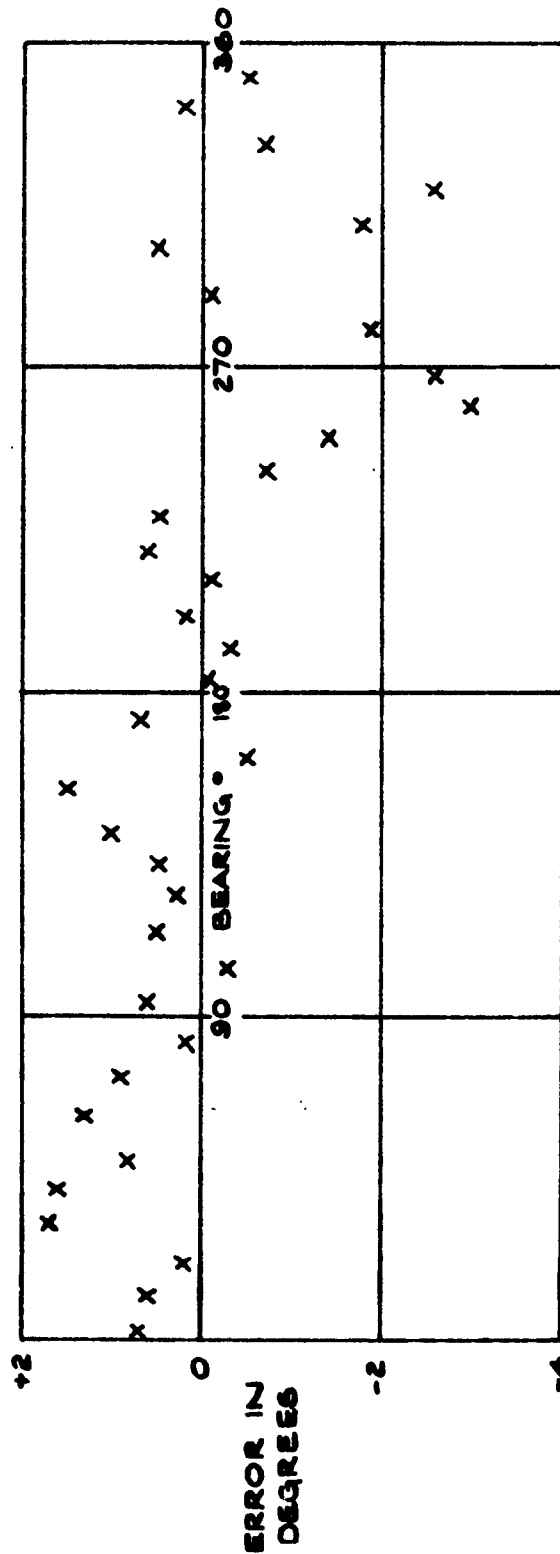
5.1.2 Ground swings of the radio compass were carried out against the Droitwich (200 Ko/s.) and Brookmans Park (908 Ko/s.) beacons. The quadrantal error correction was found to be -2 degrees as in the Mark 3 trials. The results are shown in Figures 13 and 14, the Q.E.C. was set in.

5.1.3 C.A. release is recommended for the radio compass.
